January 14th 2016

Dreaded Europa Door Hinges

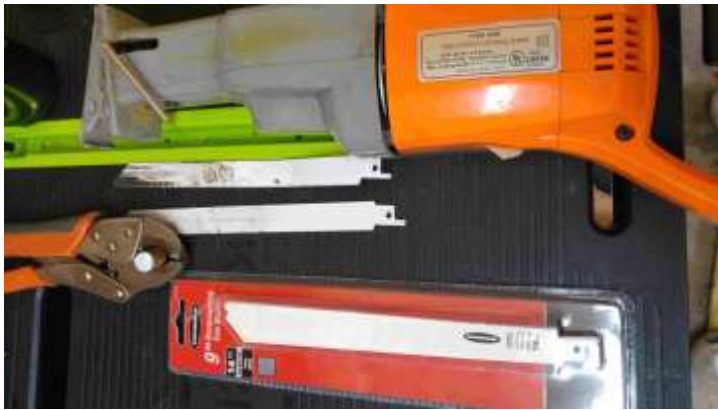
Fig 1

It was impossible to try to remove the nuts from inside as they had been covered in "Bondo" or something similarly nasty by a previous Mr Fix It. Not being the patient type and not relishing the task of hand sawing away for days, I lit a cigar poured a drink and came to the conclusion that the reciprocating saw was the way to go, I used high quality 9" blades, Fig. 1

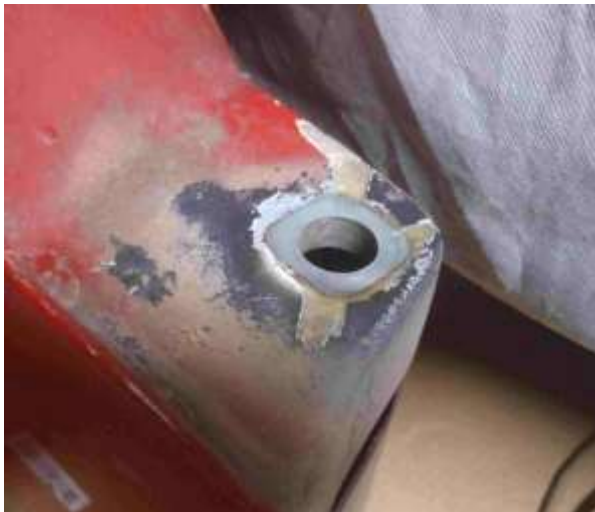
Being careful with the saw, meant there was minimal trauma to any of the bobbins. Fig 5

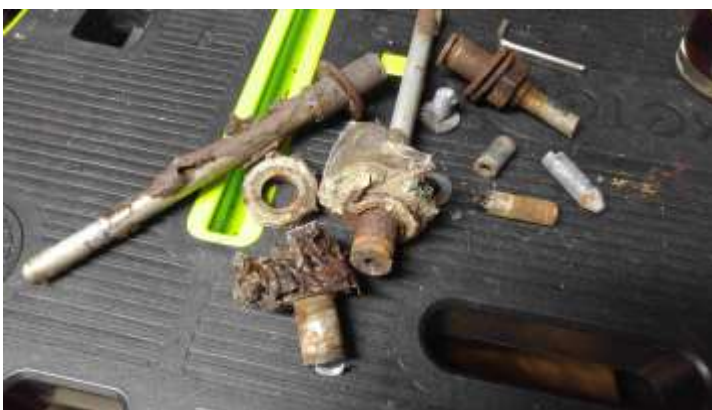
Fig 7

All in all, the total time, including celebrations between doors....took me 2 hours and still left with me sanity!. Figs 7 & 8 show what the internals looked like. Now to overhaul the window motors, I have new seals for all of the glass and need to repair one of the locks and we're ready for paint! Much easier to install the new interior with the doors removed. Hope some of this is helpful to you.
