Europa S2 Alternate Master Cylinder - The Ford Courier MC

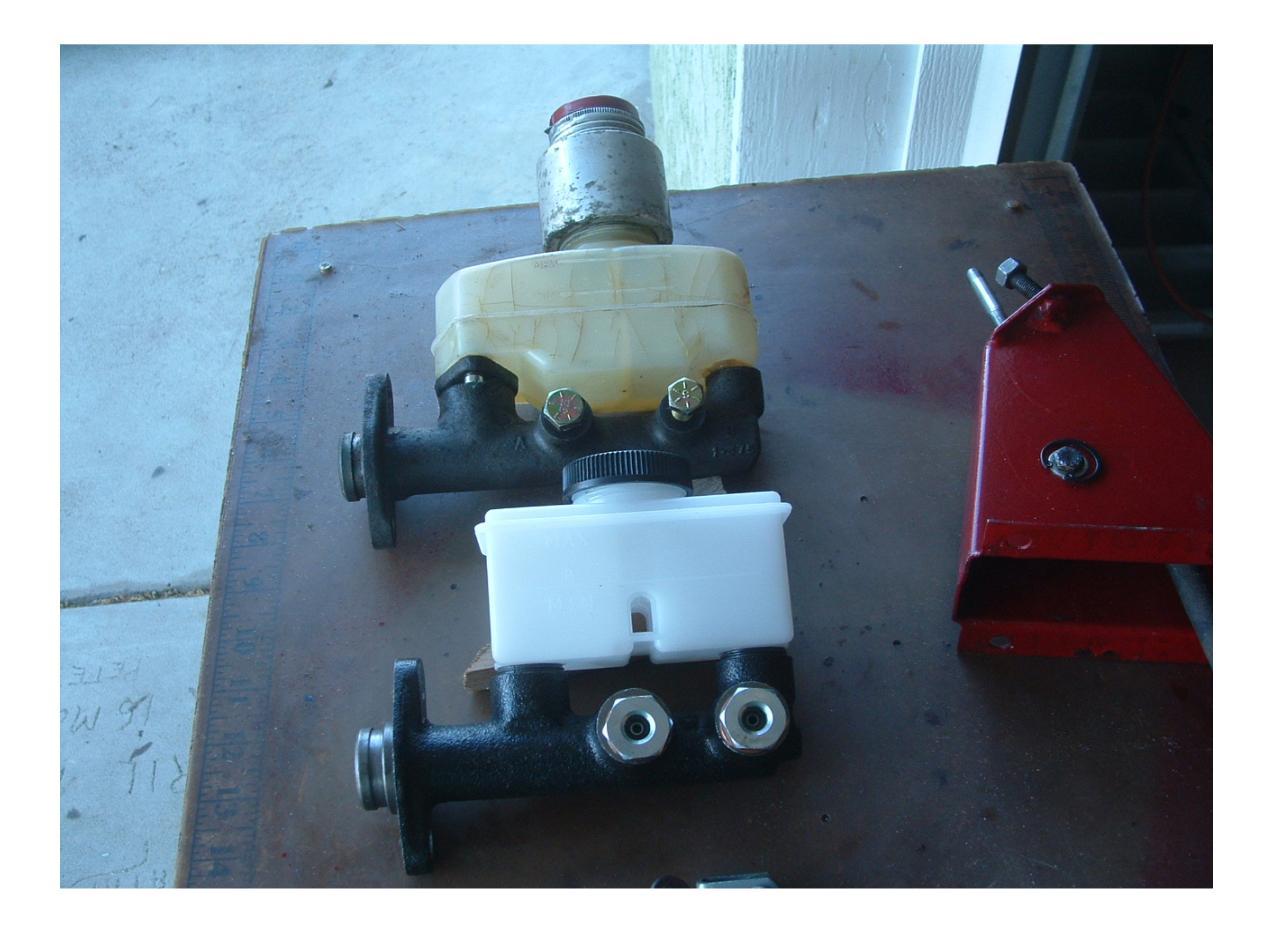
These master cylinders are still readily available from various brake component manufacturers. The one that I purchased was a Cardone 13-1777 dual circuit; 0.75" bore MC with integral reservoir. The outlet ports on the same side as the stock Girling and has a north/south orientation for the mounting flange.

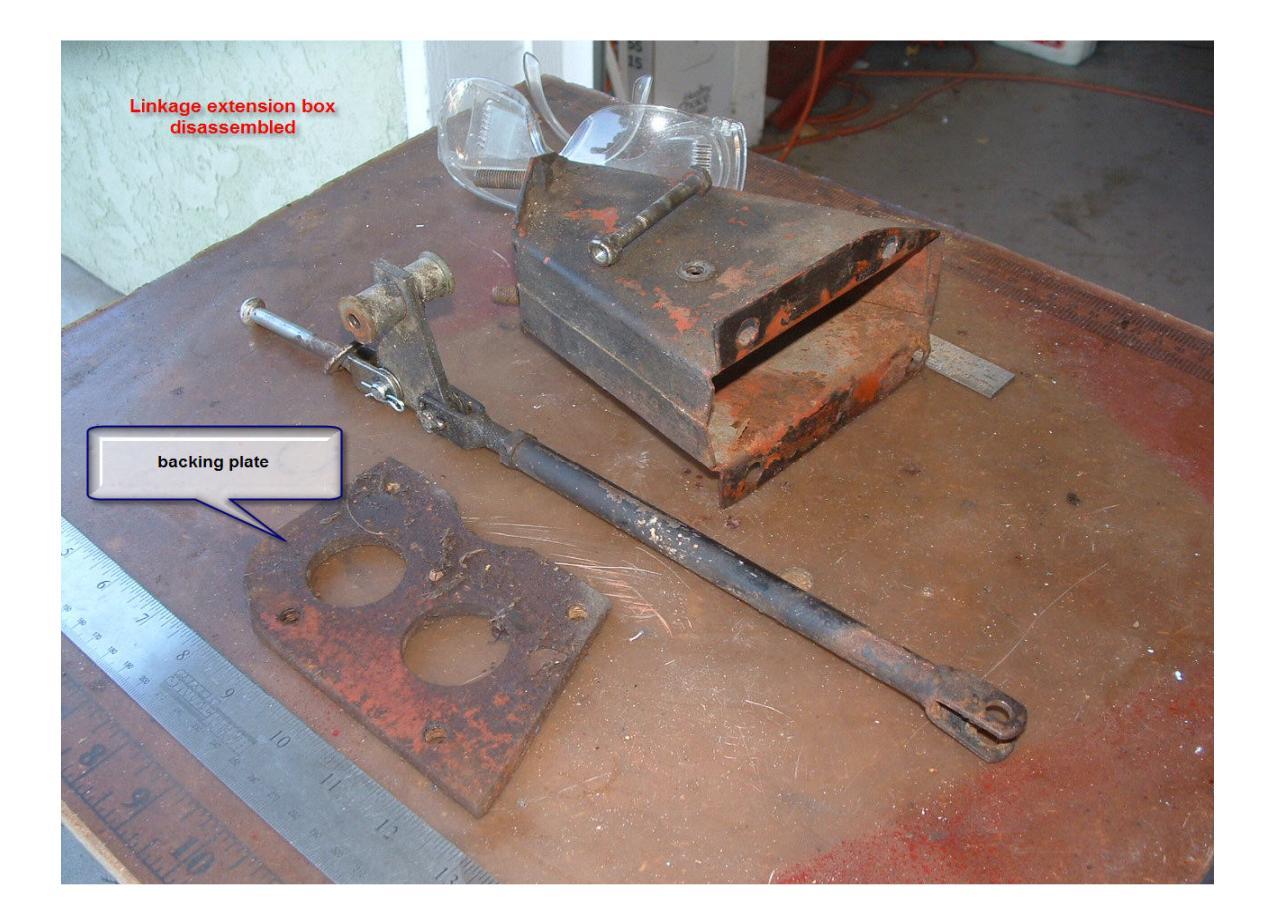
The master cylinder linkage extension box needs to be removed for this modification. Although the linkage box can be removed from the front with the closing plate attached, it is highly recommended that the closing plate be removed to aid in re-installation of the linkage box. Disconnect the brake lines from the MC and remove the stock Girling MC at this point if desired, although the MC can be removed after the linkage box is removed, on the bench. Remove the four 5/16-24 bolts attaching the linkage box to the backing plate (located inside the front chassis) with a $\frac{1}{2}$ " socket and wobbly extension. As a note, the top right bolt is impossible to get a socket on from the front due to clearance issues with the steering rack. I had to reach in from the wheel well and slip the socket on by hand then attach the extension from the front. After ensuring that the clevis pin has been removed from the brake pedal, pull the entire linkage box assembly out from the front the linkage box assembly and pull the linkage assembly from the linkage box.

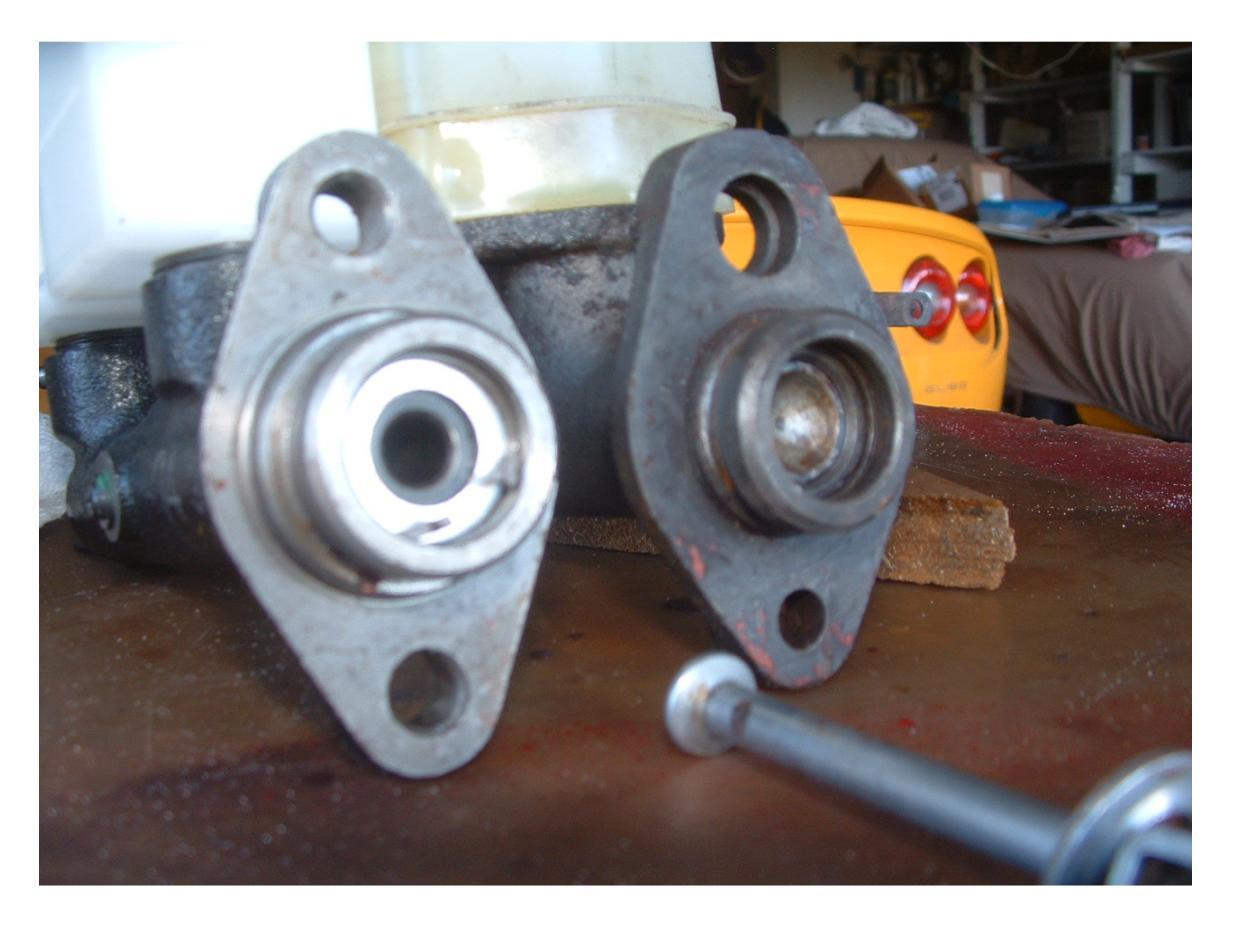
The second and most critical issue is the Girling OEM pushrod arrangement. As is, the OEM pushrod arrangement will physically fit into the bore and work with the Cardone but the primary piston of the Cardone does not have the matching hemispherical recess to accept the head of the Girling pushrod. This will cause the piston to be pushed in a few millimeters when the Girling pushrod is locked into position with the circlip into the Cardone. In effect, all pedal free play is lost and in my case, brakes started locking up within 2 miles of a test drive.

The solution is to change out the OEM pushrod for an adjustable threaded pushrod and clevis assembly. Clevises are available from Pegasus and McMaster-Carr. Threaded pushrods are available from Pegasus.

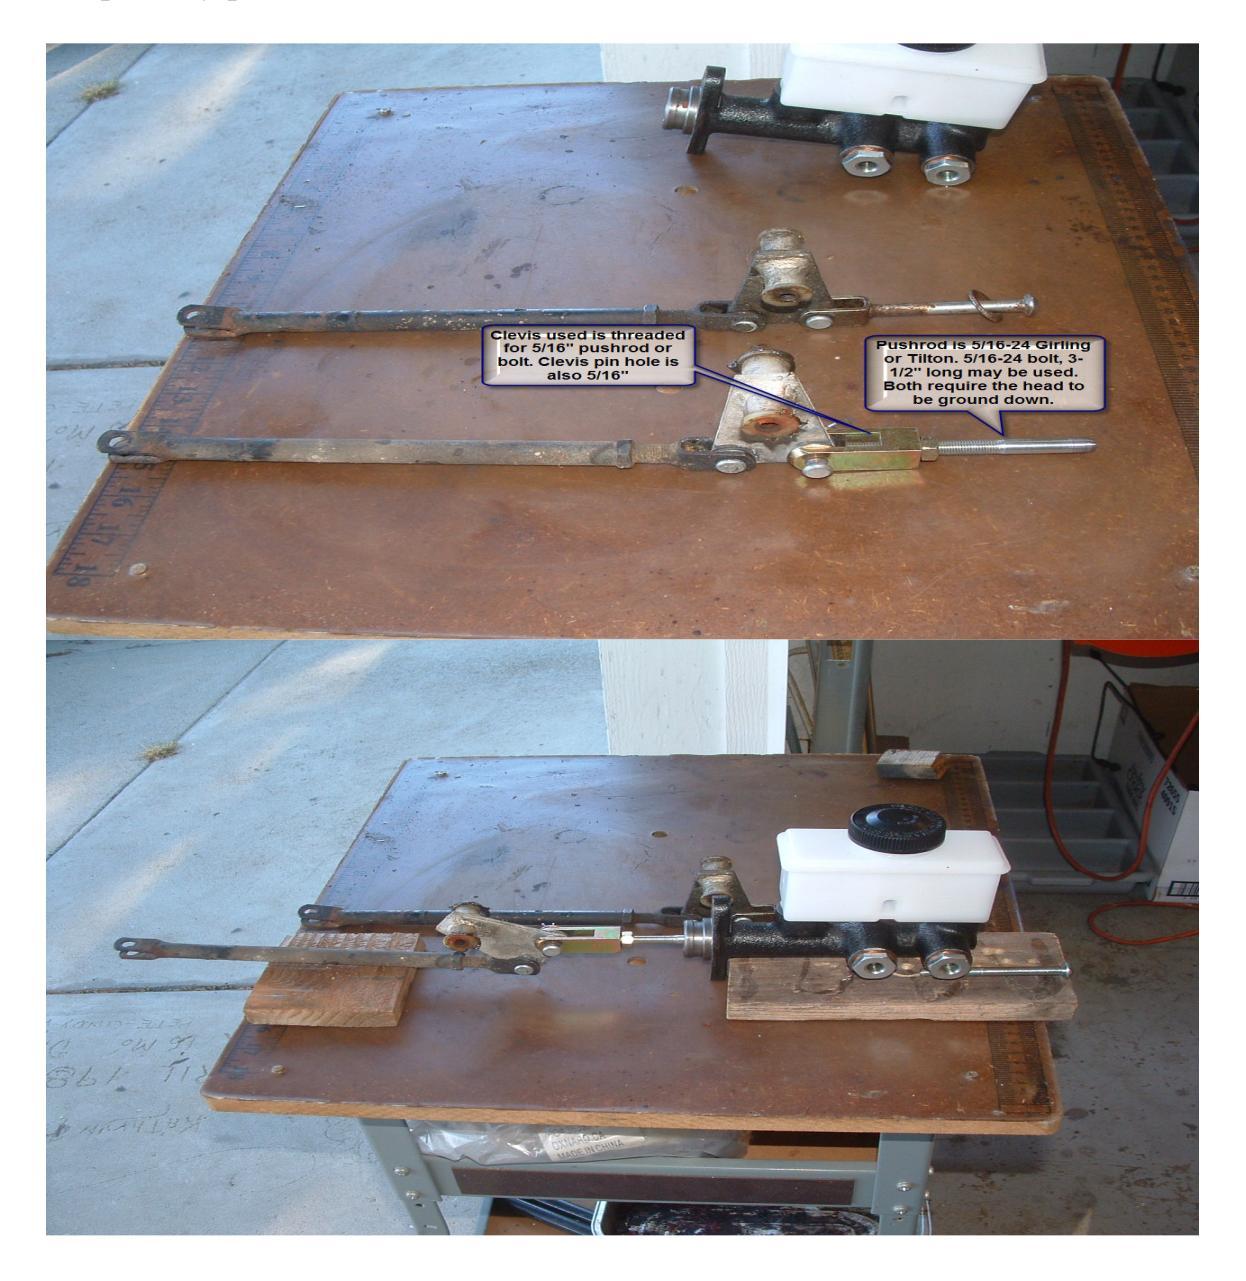
The pushrods need to be modified by grinding the heads down to the same diameter as the bolt. The modified pushrod will then fit into the 1" long cavity of the primary piston.

For those without access to a mini lathe, a bench grinder in conjunction with a portable drill works well in grinding the pushrod to a uniform tip. Secure the pushrod in a portable drill and grind the head with the drill running in the opposite direction as the grinder. Polish the head in a bench drill press and Emory cloth till the head is smooth. As a note, threaded pushrods from Pegasus cost \$15, grade 5, 4" long 5/16-24 hex head bolts from a hardware store cost \$1.20. Either one can be used.

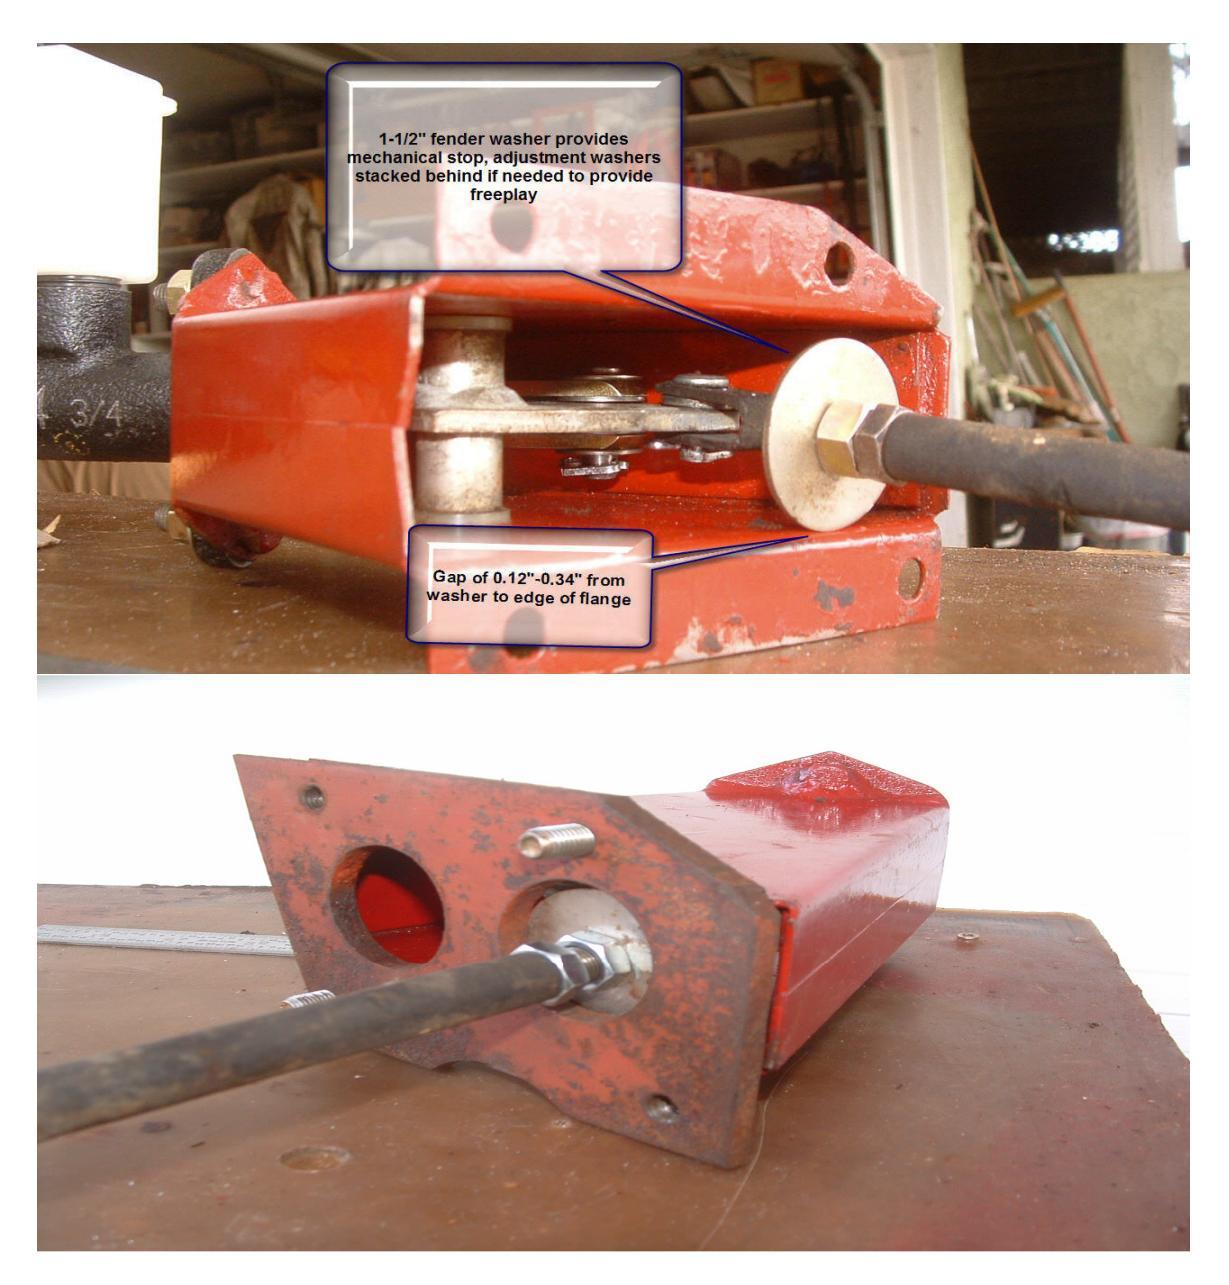
The third issue is providing a mechanical stop for the brake pedal. With the OEM Girling MC, the pushrod captured by the washer and snap ring in the MC bore. With the Cardone, nothing restrains the pushrod from being pulled out of the MC. My solution is to secure a $1-\frac{1}{2}$ " fender washer to the brake operating rod. The washer provides the mechanical stop for the brake system and allows free play adjustment using washers behind the fender washer. Installing a mechanical stop is essential for this modification.

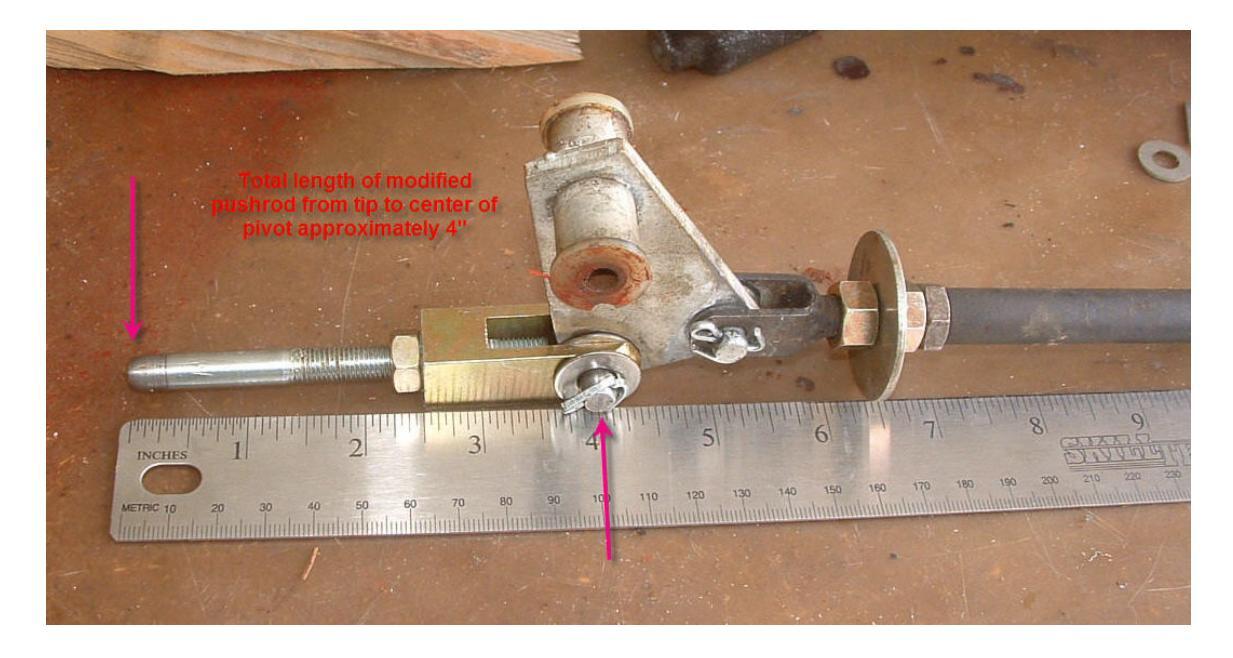
The Ford brake system on the Courier was designed to use a long single rod from the brake pedal to the master cylinder. On the Europa, the arc that the pushrod makes from rest to full travel within the bore of the master cylinder is a major concern due to the possibility of the rod binding inside the bore of the primary piston. Without changing the stock pivot point, I believe that keeping the pushrod fairly short will minimize any chance of the rod binding with the primary piston. The second concern is achieving full pushrod travel during brake actuation without the clevis hitting the back of the MC bore. I'm using approximately 4" from the tip of the pushrod to the centerline of the pivot. This length provides a smooth operation and full length rod travel on the bench. Full travel of both primary and secondary pistons in the MC is only necessary to achieve full bench bleeding of the MC. Verify pushrod travel by bolting on the MC to the linkage box with proper torque and observing the pushrod from the rear of the linkage box as the brake operating rod that is connected to the brake pedal is pushed in. If travel length is satisfactory, remove the MC, mark the position of the pushrod in the clevis, apply thread lock to the pushrod, and then screw in to its permanent position.
